### NAVY EXPERIMENTAL DIVING UNIT **TECHNICAL REPORT NO. 5-99**

### **EVALUATION OF EMERGENCY EVACUATION** HYPERBARIC STRETCHERS (EEHS)

SEPTEMBER 1999

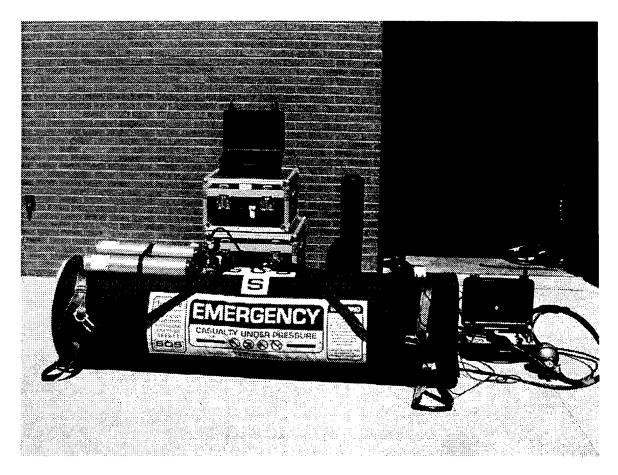
ILLUSTRATION A-1. SOS HYPERLITE EEHS SYSTEM.

Hyperlite's medical lock is small, but functional. It is simple and easy to operate.
 It does not obstruct the view of the patient. The only problem noted was that it

- On the Hyperlite, hoses enter at the center of the end plates in a long axis orientation. They are not subject to damage if the unit rolls or must pass through a narrow opening during transport.

- Light Hyperlite hull is opaque, but entire end domes are transparent. This
  allows in plenty of light for reading, and allows some view of the outside. This
  also allows the patient to be seen easily from either end of the chamber. GSE
  is semi-translucent, and end domes are metal with small windows. There is
  adequate light, but the view from the inside is limited. It is very difficult to
  monitor the patient well.
- Space GSE is larger in diameter. The extra space allows the patient to
  partially sit, turn easily, and even reverse position within the chamber. The
  smaller size of the Hyperlite is a problem for some patients. Confinement
  anxiety is greater in the Hyperlite, but was generally not problematic.
- Noise Noise levels were not a problem in either chamber. Both chambers allowed communication through the hull if necessary.

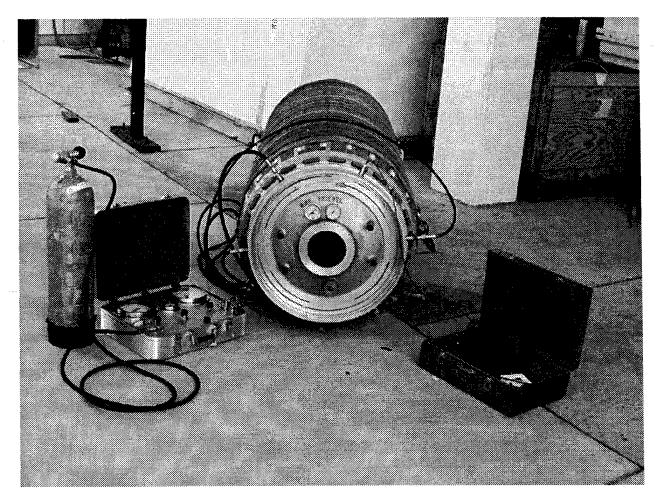
ILLUSTRATION A-2. GSE FLEXIBLE HYPERBARIC EEHS SYSTEM

- could be inadvertently left open during assembly, causing a leak during pressurization. When this occurs, it is obvious and easy to correct quickly.
- The GSE medical lock is large and heavy, and must be installed at one end of the chamber in place of a viewport. It obstructs the view from the affected end.

- On the GSE, hoses enter the end plate rim in the cross sectional axis, as a spoke would enter a hub. They are subject to damage, even dislodgment, if the unit is rolled. They protrude in such a way that they would interfere with transport through a narrow opening.

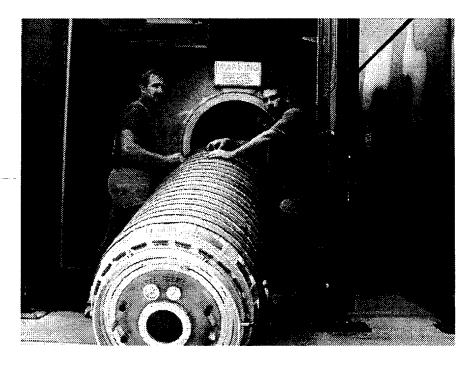
- While it was possible to load the GSE Flexible Hyperbaric into the NEDU treatment chamber, it was awkward and difficult. The extra size created difficulty in clearing the space for the hatches to swing to the closed position. The extra weight was difficult to lift over the lip of the entrance, and to position in the chamber. It was hazardous to the personnel, with a significant risk for back strain due to the awkward lifting positions necessary. It is not possible to load the GSE Flexible Hyperbaric 30-inch models (76 cm) (the unit that was tested) into a Dixie Double Lock chamber. The diameter of this EEHS is larger than the diameter of the opening to the Dixie Double Lock. Thus, for use as an evacuation device, it is not compatible with the most common receiving

ILLUSTRATION A-3. GSE FLEXIBLE HYPERBARIC WILL NOT FIT INTO STANDARD U.S. NAVY DIXIE DOUBLE-LOCK CHAMBER.
